# CASE STUDY TECHNICAL SHEET

## Case study 1 – Agricultural processing building, Kelowna, British Columbia

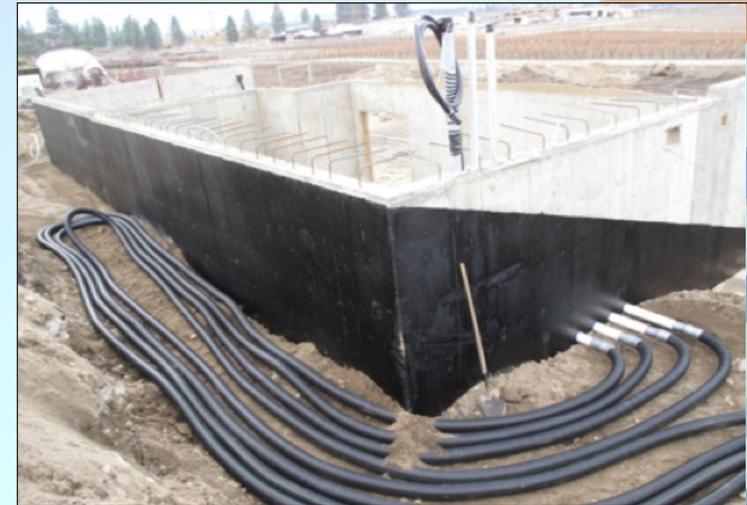
Figure 1. The layout of tubes with lower layer already backfilled

Pipes	8
Pipe depth	2.4 m
Pipe length	30.0 m average, each
Pipe internal diameter	100 mm
Material	HDPE
Airflow rate (L/s)	100.0 L/s, total (approx. 12.5 l/s per pipe)
Building type	agricultural, processing
Geographical location	Kelowna, Canada
Maximum heating delta T <sup>1</sup>	16°C
Maximum cooling delta T	-19°C
Distance between pipes	0.2m

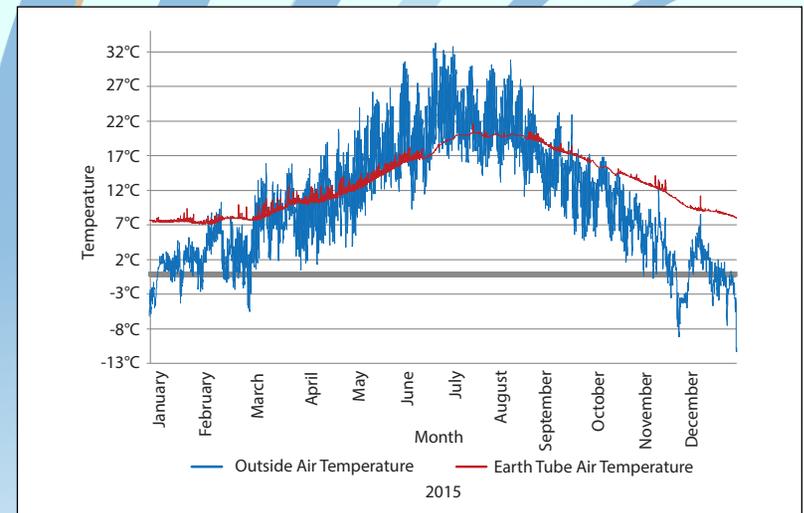
Figure 2. Energy performance of the system, 2015

<sup>1</sup> Delta T is the temperature difference between the pipe inlet and pipe outlet.

The earth tube system was monitored for more than a year, starting in 2015. The results indicate a well-performing system. The small diameter and depth of the pipes, as well as the low air velocity all contribute to the high-performance output of this system.

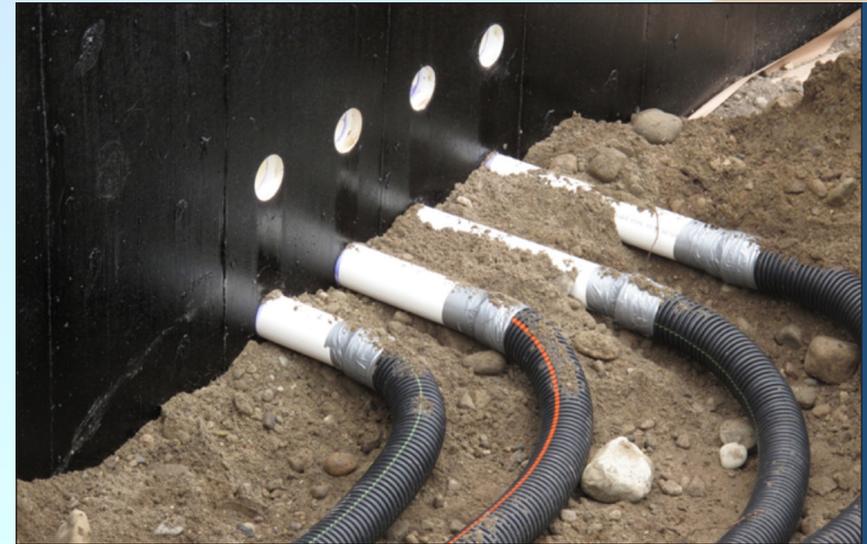
**Figure 3. Watertight connection of tubes to a building**

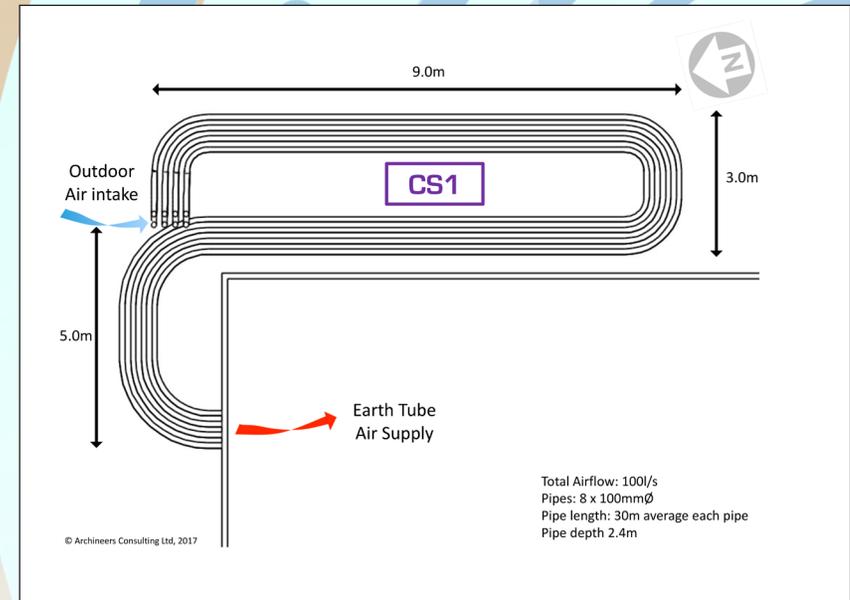
**Fig 4. Pipe layout**
